TECHNICAL NOTE 4263

EFFECT OF PRIOR AIR FORCE OVERTEMPERATURE
OPERATION ON LIFE OF J47 BUCKETS EVALUATED
IN A SEA-LEVEL CYCLIC ENGINE TEST

By Robert A. Signorelli, James R. Johnston, and Floyd B. Garrett

Lewis Flight Propulsion Laboratory
Cleveland, Ohio

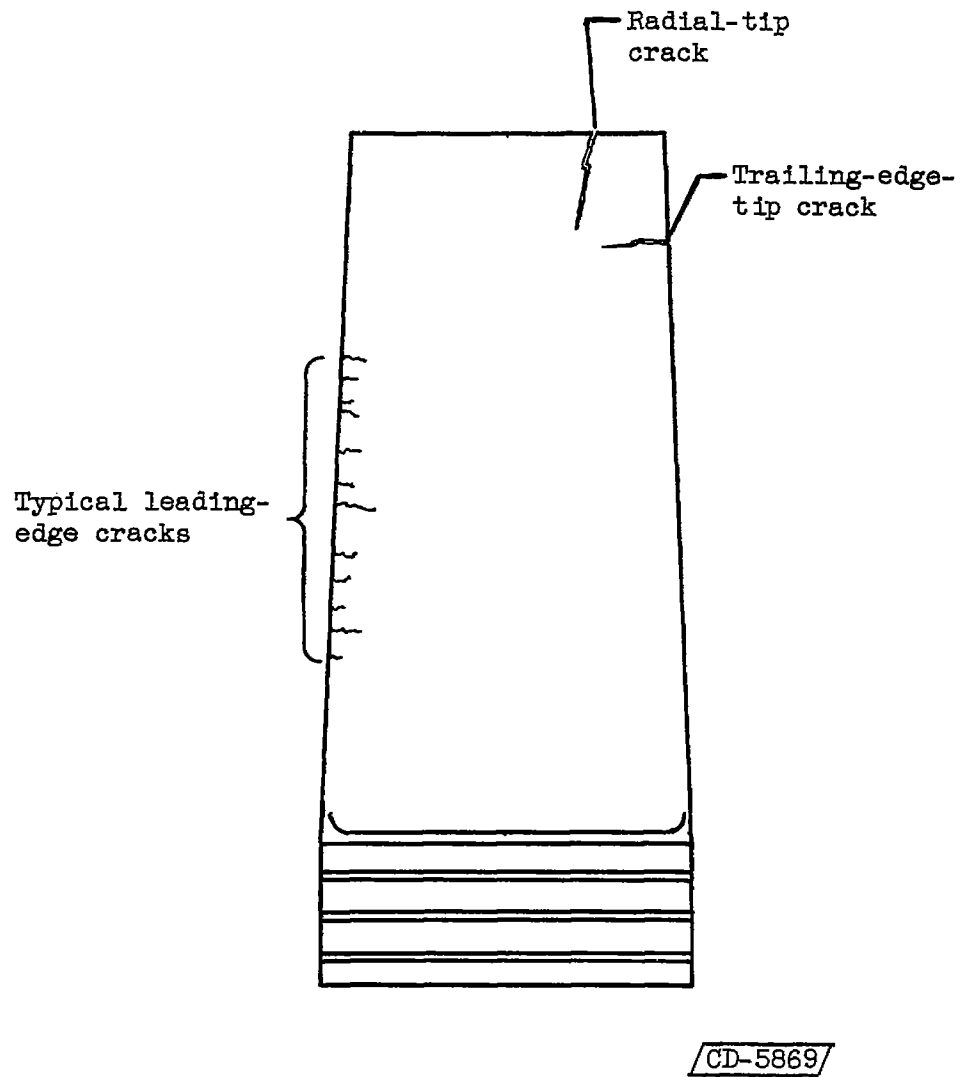
Figure 3. - Crack classification.

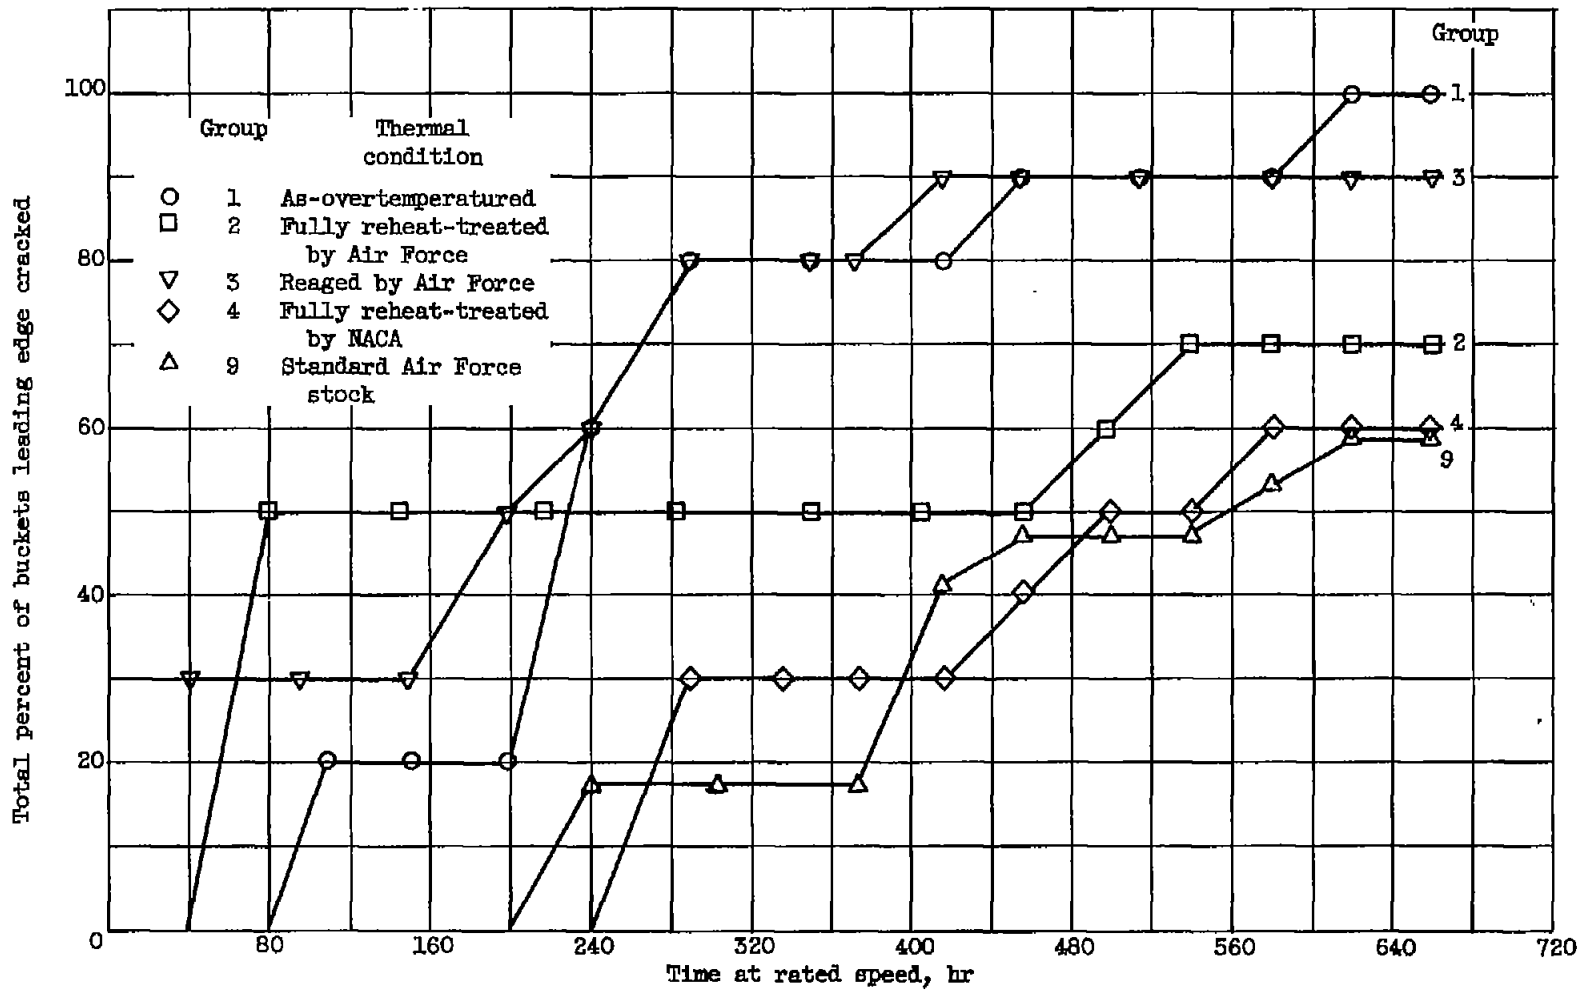
(a) Engine A buckets.

Leading-edge cracking. - The leading-edge cracking data have been plotted in figure 5. Figure 5(a) shows the cumulative percentages of buckets with leading-edge cracks for each of the groups of buckets originally obtained from engine A (groups 1 to 4). The percentages of buckets with leading-edge cracks is plotted against engine test time. Figure 5(b) shows similar data for the groups of buckets originally obtained from engine B (groups 5 to 8). For comparison, both figures show leading-edge cracking data for the standard Air Force stock buckets (group 9). Buckets of the as-overtempered groups (1 and 5) and the overtempered and reaged groups (3 and 7) developed leading-edge cracks more readily than buckets in the other groups. After 240 hours of operation, leading-edge cracks were present in 60 percent of the buckets of groups 1 and 3 and in 40 and 70 percent, respectively, of buckets of groups 5 and 7 (fig. 5). Only 18 percent of the standard Air Force stock buckets (group 9) had leading-edge cracks after 240 hours. However, the group 9 buckets were new when they were installed in the engine test, while all other groups had a prior service life. The service life of the buckets is not known, but the flight time on the engines was 209 and 242 hours, respectively, for engines A and B. Perhaps the prior service life, rather than overtemperature, accounts for the larger number of leading-edge cracked buckets.

In this investigation, resistance to leading-edge cracking appears to have been increased by the full standard heat treatment of as-overnatured buckets. As may be noted in figure 5, groups 2, 4, 6, and 8 had lower incidences of leading-edge cracking than did the as-overnatured groups, 1 and 5. In fact, the incidence of leading-edge cracking of the fully reheat-treated groups was about the same as the new standard-group buckets.

Figure 5. - Leading-edge cracking with time at rated speed.

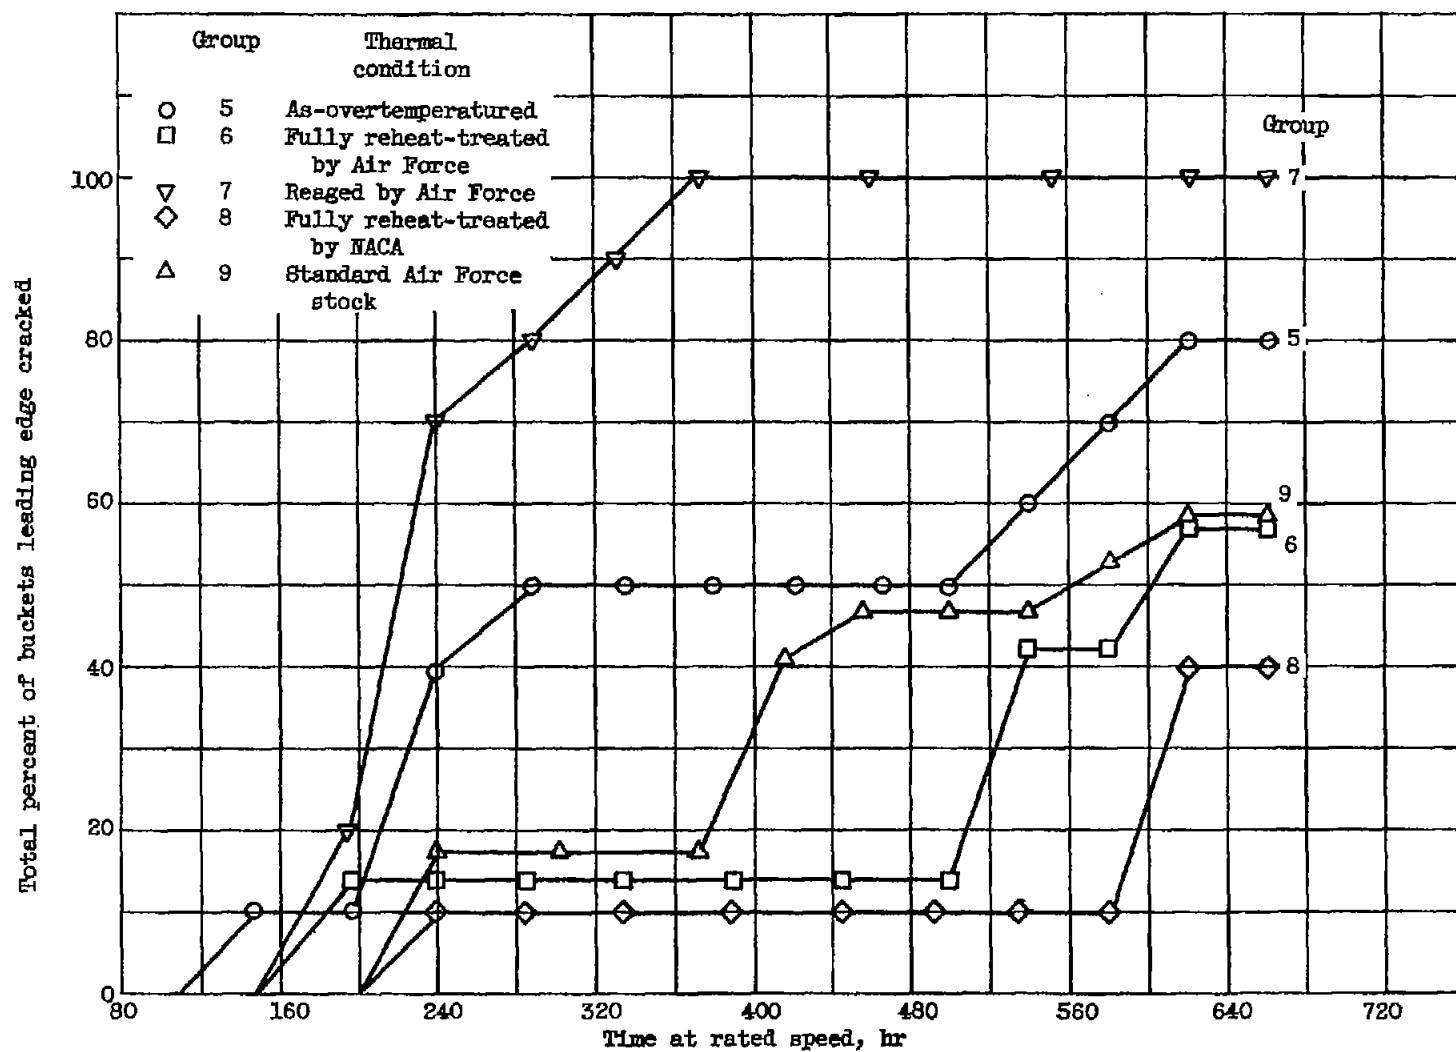
(b) Engine B buckets.

Figure 5. - Concluded. Leading-edge cracking with time at rated speed.

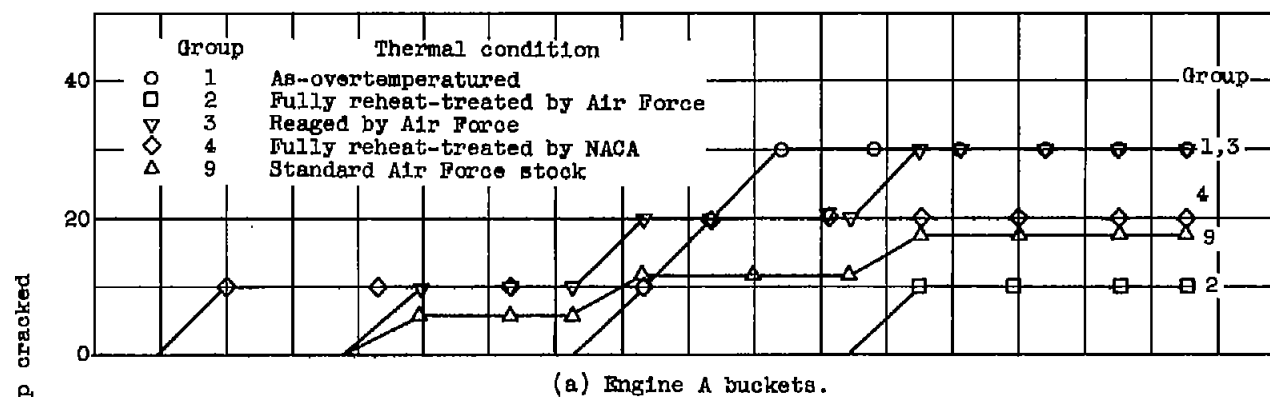
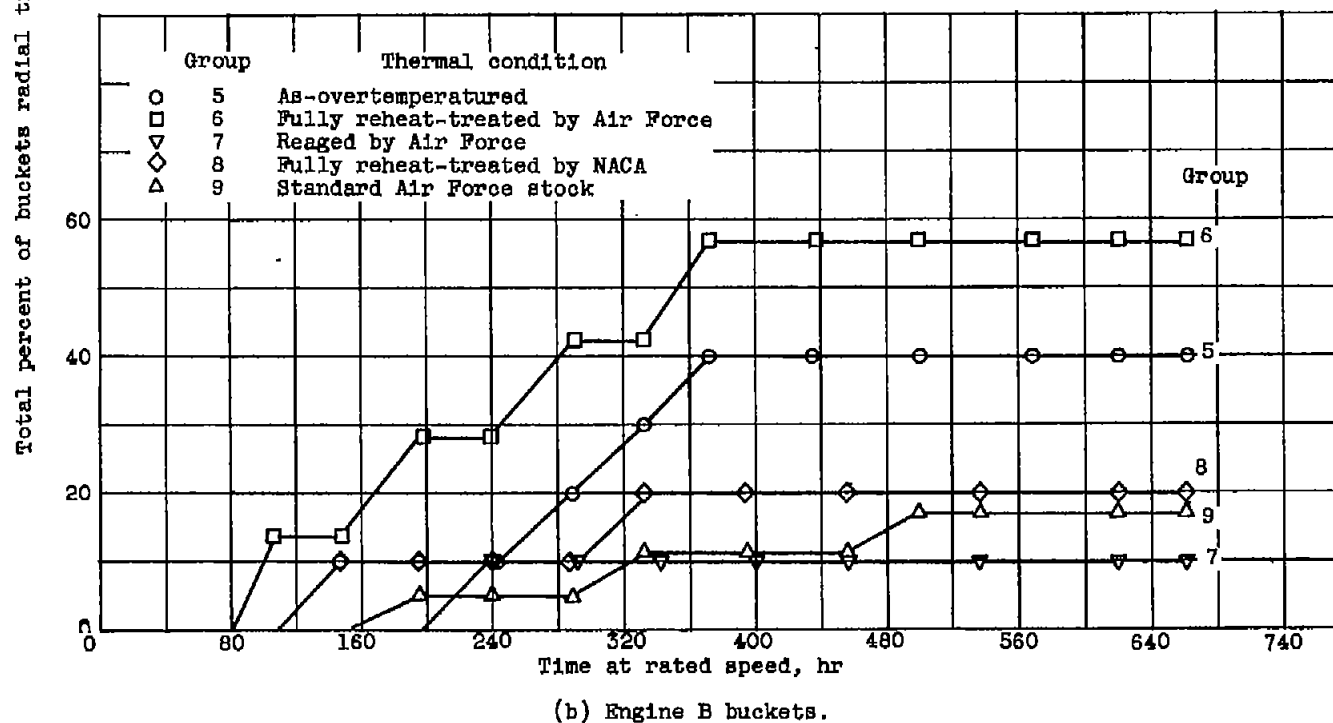
Radial-tip cracking. - The incidence of radial-tip cracking is shown in figure 6. The difference between the bucket groups in the incidence of radial-tip cracking was less than that obtained for leading-edge

4567 cracking. The data in figure 6(a) show little difference in incidence of radial-tip cracking among bucket groups from engine A. Upon first examination of figure 6(b), however, there might appear to be a significant difference in the incidence of radial-tip cracking among bucket groups from engine B. Particularly, it would appear that the group given a full reheat treatment by the Air Force (group 6) has a greater incidence of tip cracking than does the group given the full reheat treatment by the NACA (group 8). The noted difference is not believed to be significant, however, since, in the case of the similar groups of engine A (groups 2 and 4) no detrimental effect of the Air Force treatment was noted; and, even in the case of the previously discussed leading-edge cracking (fig. 5(b)), the effect of the full reheat treatment was about the same, whether given by the Air Force (group 6) or NACA (group 8).

Figure 6. - Radial-tip cracking with time at rated speed.

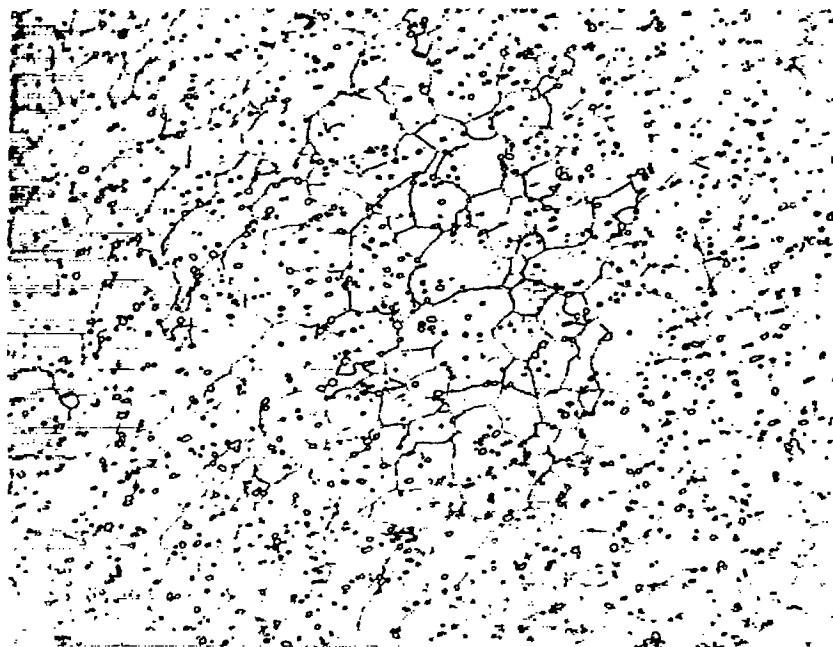
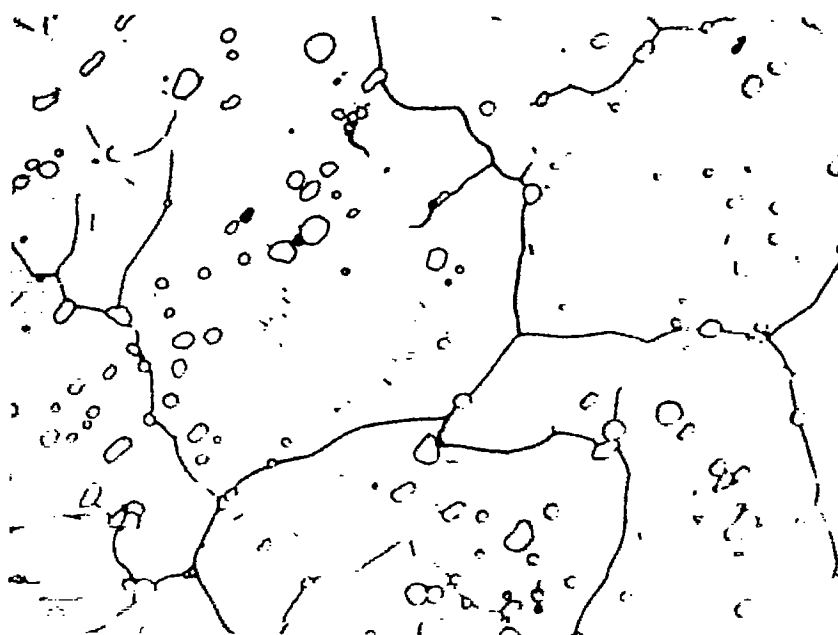
(a) Group 9, standard S-816.

Untested buckets. - Typical microstructures of bucket from the overtemperated groups and the standard group before engine testing are shown in figure 7. The standard heat-treated S-816 alloy bucket (fig. 7(a)) has large, stable, columbium-tantalum carbide precipitates in the matrix and continuous grain-boundary precipitation. The as-overtemperated bucket microstructures (groups 1 and 5) in figure 7(b) show agglomeration and spheroidization of grain-boundary precipitates that have been associated with overtemperature, as described earlier. Although the photomicrographs of the specific buckets of figure 7(b) indicate slightly more hyphenation of grain-boundary precipitation for group 1 than for group 5, examination of microstructures of a number of buckets from groups 1 and 5 indicates that the degree of hyphenation is about equivalent for the two groups of buckets. Buckets of groups 2, 4, 6, and 8, overtemperated and reheat-treated, are shown in figures 7(c) and (e). The microstructures are typical of S-816 in the normal heat-treated condition. The microstructural evidence associated with overtemperature is no longer visible. The overtemperated and reaged buckets of groups 3 and 7 are shown by the microstructures in figure 7(d). The precipitation

Figure 7. - Microstructures of untested buckets.
Etchant, aqua regia plus glycerol.

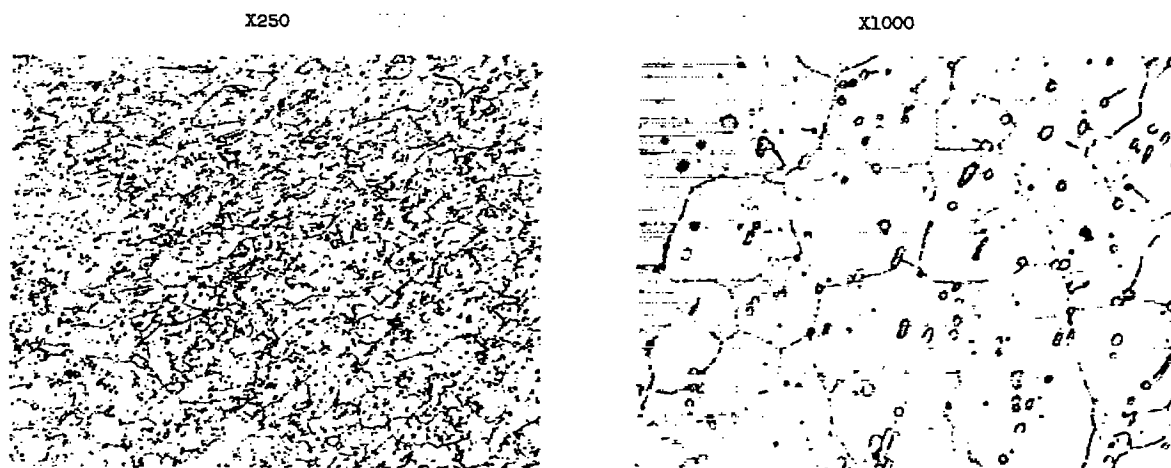
Group 1, overtemperated in engine A

Group 5, overtemperated in engine B

(b) As-overtemperated buckets.

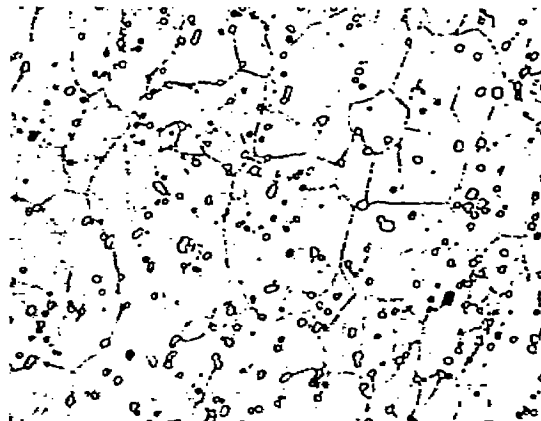
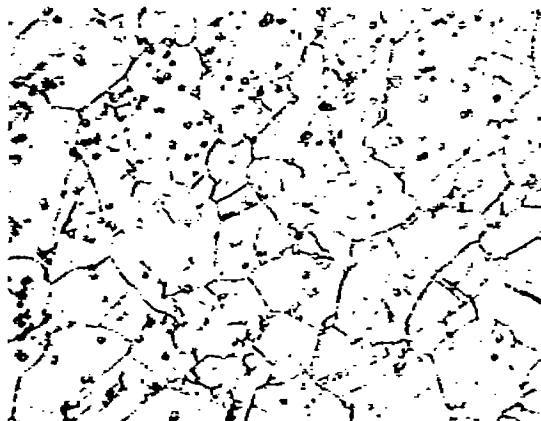
Group 3, overheated in engine A and reaged.

Group 7, overheated in engine B and reaged

(d) Buckets overheated and reaged by Air Force.

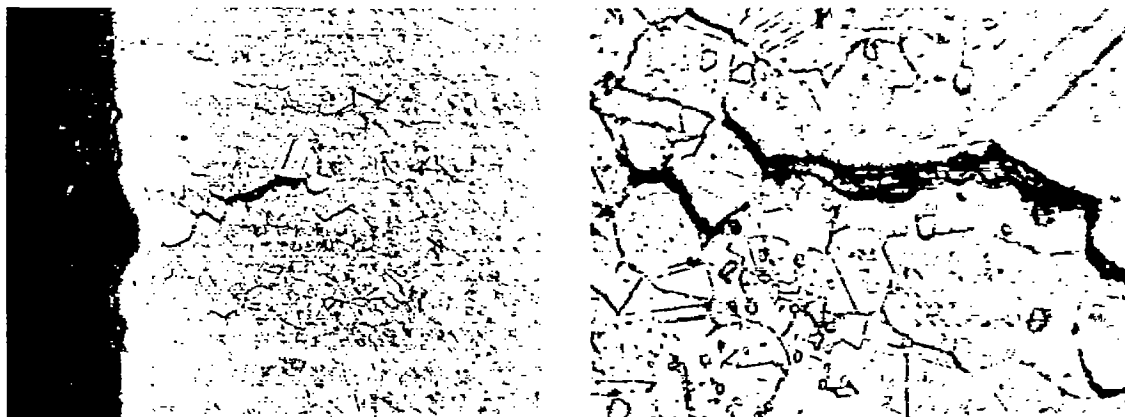
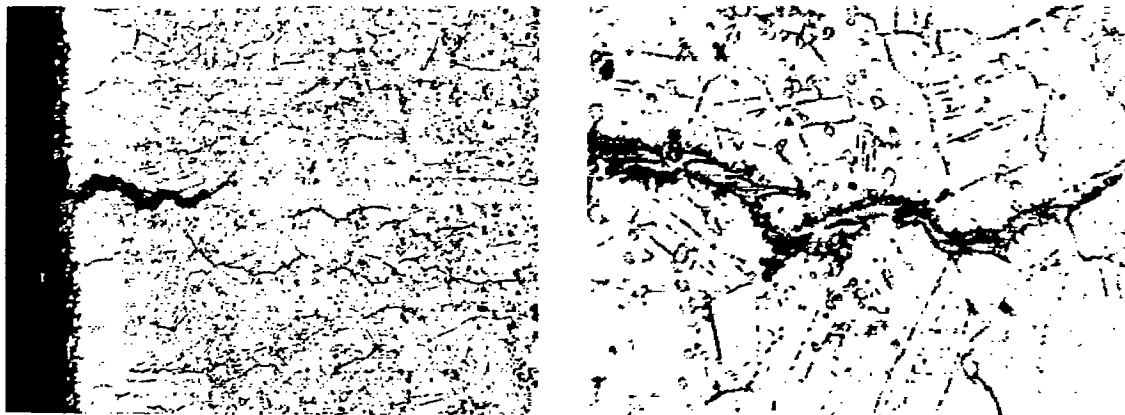
Engine-tested buckets. - Microstructural studies of buckets after engine testing are presented in figure 8. Buckets of all groups showed an advanced stage of aging, with little or no microstructural difference among groups. Several small leading-edge cracks are also shown in the photomicrographs. Small cracks with less oxidation than the larger cracks were photographed because oxidation obscured the surfaces of larger cracks and hampered classification of cracks as intergranular or transgranular.

Group 1, overtemperated in engine A

Group 5, overtemperated in engine B

Figure 8. - Microstructures after engine test.

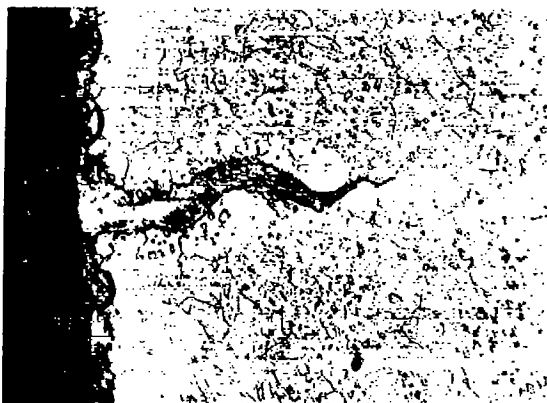
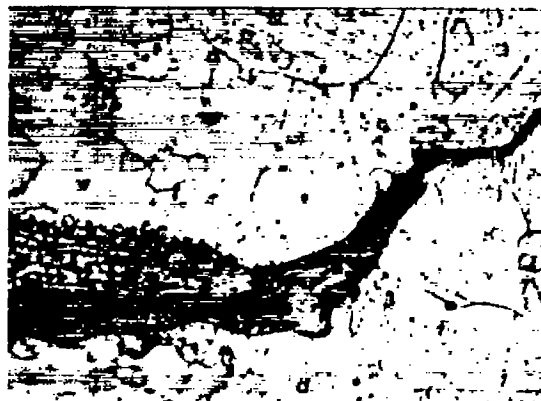
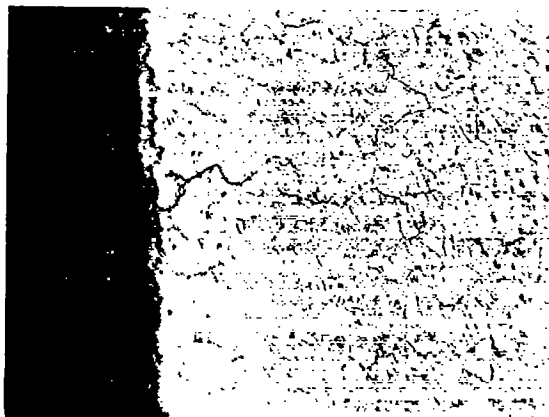
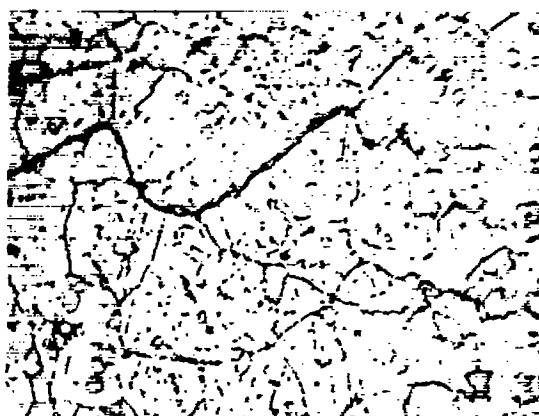
Group 2, overheated in engine A and reheat-treated

Group 6, overheated in engine B and reheat-treated

(b) Buckets overheated and reheat-treated by Air Force.

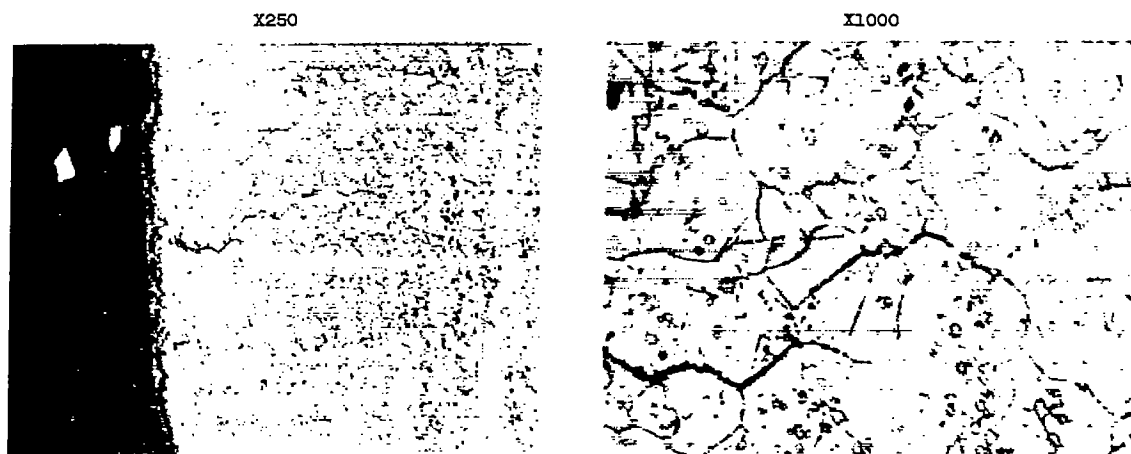
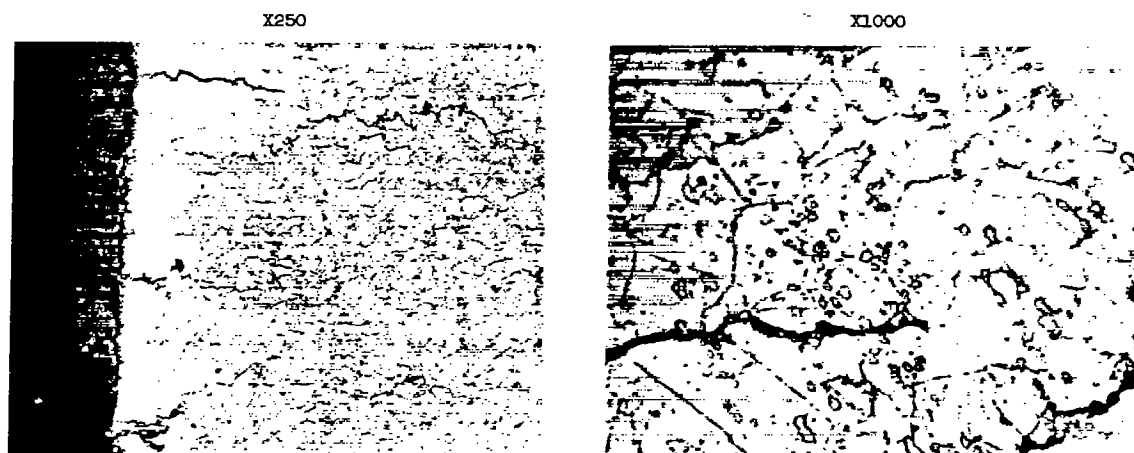
Group 3, overheated in engine A and reaged

Group 7, overheated in engine B and reaged

Figure 8. - Continued. Microstructures after engine test.

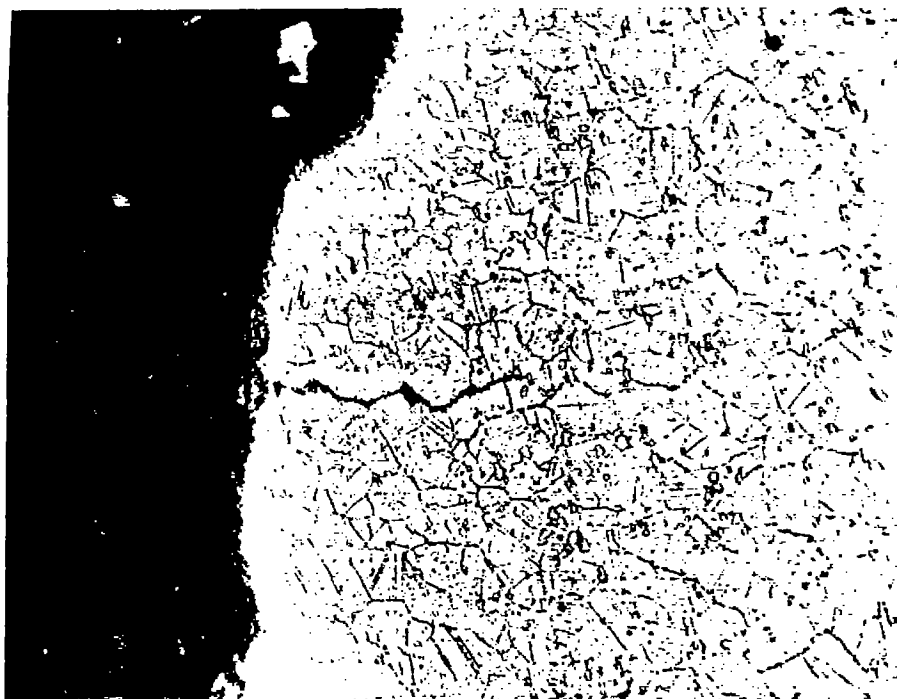
(d) Group 9, standard S-816.

Figure 8. - Concluded. Microstructures after engine test.

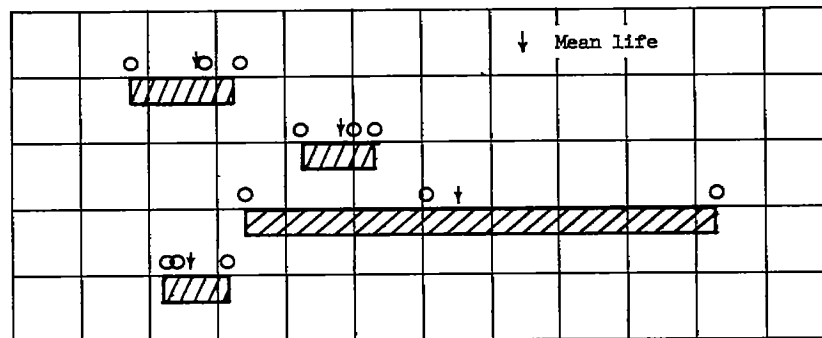
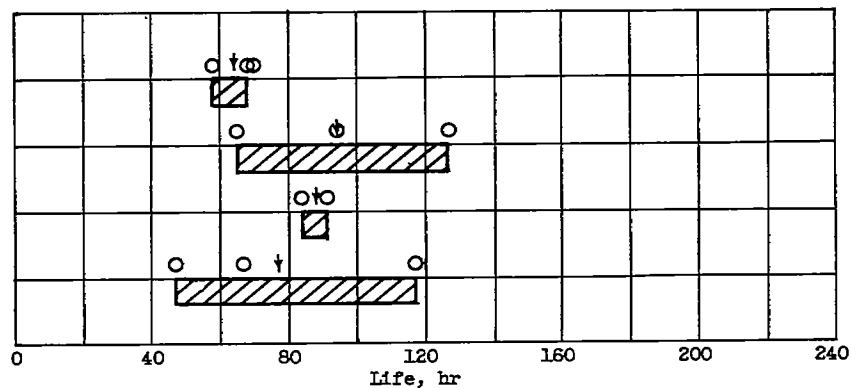
Stress-rupture results. - Stress-rupture lives of specimens cut from the airfoil of buckets of each group are shown in figure 11. All specimens were tested at 1500° F and 23,600 pounds per square inch, which are the conditions for a nominal life of 100 hours for standard S-816 alloy bar stock. Stress and temperature conditions in a range corresponding to that in buckets during the engine test were not used, since the life of specimens would have been too long. For example, at a point 2 inches above the base of the airfoil, which is in the zone where stress-rupture life of buckets is at a minimum, bucket centrifugal stress is about 10,400 pounds per square inch and bucket temperature is about 1470° F (fig. 1). Stress-rupture life at these conditions is of the order of 30,000 hours for S-816. The mean stress-rupture life of specimens from standard S-816 buckets was 94 hours, which is reasonably close to the nominal 100-hour life for bar stock. The as-overtempered groups had shorter stress-rupture lives than the standard group, with mean lives of 54 and 64 hours for groups 1 and 5, respectively. The test bars from the fully reheat-treated groups showed an improvement in life over the as-overtempered group bars; this indicated some recovery of stress-rupture properties. The mean lives of 86, 130, 94, and 88 hours are about equivalent to the standard group. The as-overtempered and

As noted in the results, the stress-rupture properties of the various groups differed appreciably. The stress-rupture life of specimens from as-overnatured buckets and overnatured and aged buckets was lower than that of standard-bucket specimens (fig. 11). This might be expected because overtemperature exposure can reduce stress-rupture properties of S-816 alloy, as has been shown in the laboratory and engine studies (refs. 2 and 3).

(b) Engine A. Temperature, over 1800° F (tailpipe) on acceleration.

(c) Engine B. Temperature, over 1500° F (tailpipe); engine overspeed, 104 percent.

Figure 11. - Stress-rupture results of specimens from bucket airfoils.
Stress, 23,600 pounds per square inch; temperature, 1500° F.
